# Manhole Inspection Summary

Manhole # S21A\_\_048MH

Insp Date: **9/18/07 10:50 AM**

**Location** Address: **600 FULTON AVE**

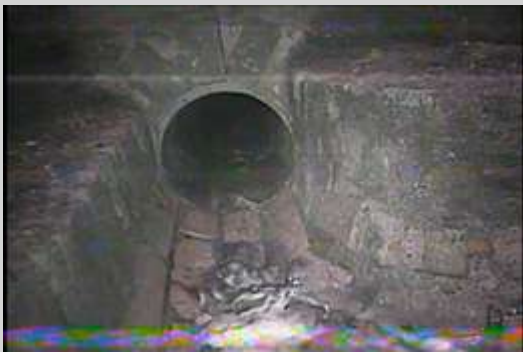
12 O'Clock Outflow

Pipe Height: **8.4** (in.) Rod and Bar (Angled)  
Pipe Material: **Clay** ☐ Pipe Lined  
Invert Depth: **11.97** (ft.) Flow Characteristics: **Slow**  
Deposits: ☒ None ☐ Mud ☐ Sludge ☐ Debris ☐ Grease  
Silt Depth: (in.) Deposits Extent:  
Infiltration: **None** Pipe Seal Cond: **Sound**

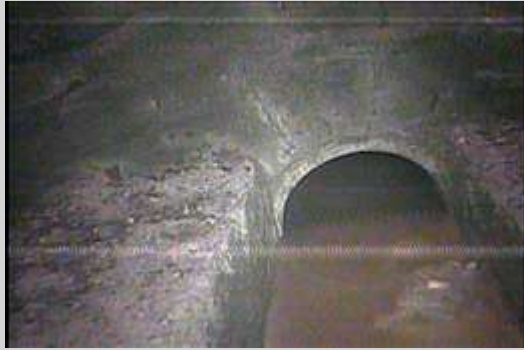
6 O'Clock Inflow

Pipe Height: **8.4** (in.) Rod and Bar (Angled)

Infiltration: **None** Pipe Seal Cond: **Sound**
